Desktop 3rd Generation Intel[®] Core[™] Processor Family

Specification Update

April 2016

Revision 022

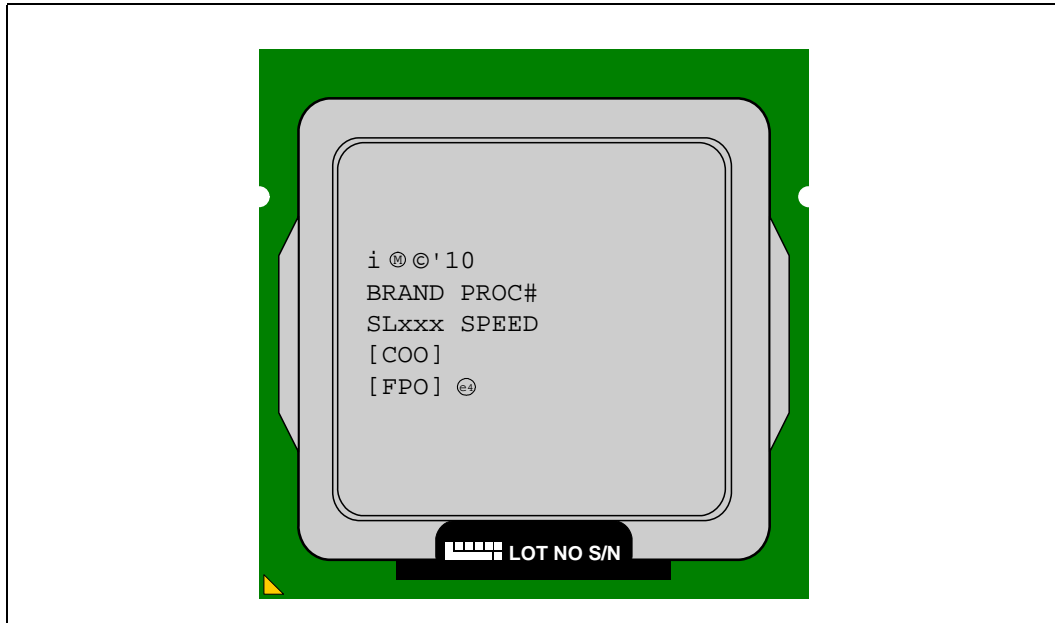
Figure 1. Processor Production Top-side Markings (Example)

The processor stepping can be identified by the following component markings.
