Intel[®] C620 Series Chipset Platform Controller Hub

Specification Update

April 2019

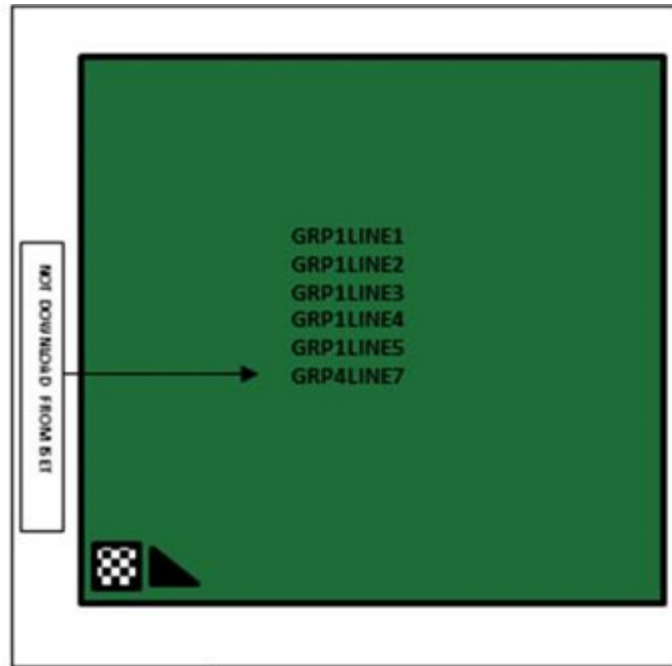
Component Marking Information

The Intel C620 series can be identified by the following component markings.

Legend	Text
Gripline1	
Gripline2	Intel {R} SKU
Gripline3	
Gripline4	Sspec number
Gripline5	{FPO} [e1]
